Four Point Report

99 Sample St, Somewhere FL, 12345

4-Point Inspection Form

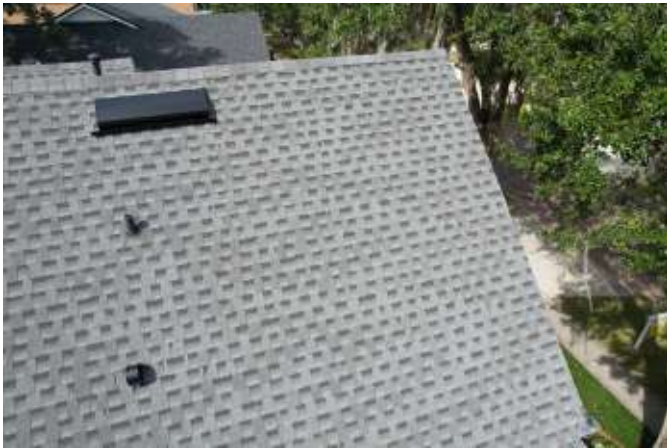
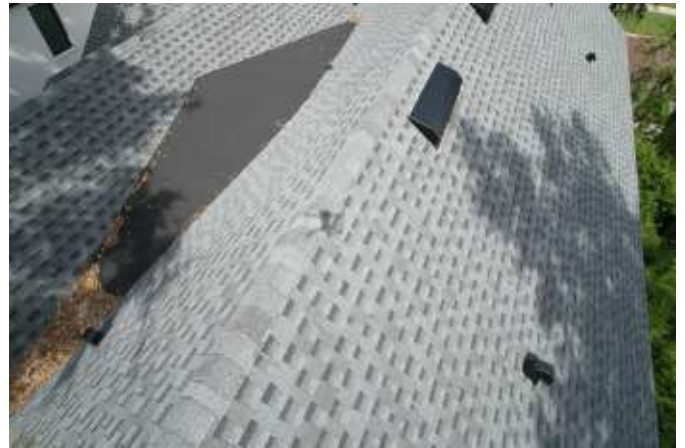
Additional Comments/Observations (use additional pages if needed): **Wood rot and evidence of moisture intrusion in the attic indicate a potential leak.**

Evidence of moisture intrusion.
