Inspection Report

99 Sample St. Somewhere FL 12345

Date: 3/23/2023	Time: 11:30 AM	Report ID: 5555555
Property:	Customer:	Real Estate Professional:
99 Sample St.	Mr. John Doe	Jane Someone
Somewhere FL 12345		Top Selling Realty

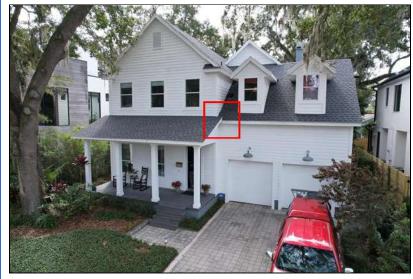
1.2 Item 1(Picture)

- **1**.2
 - (Observation): Damaged siding and exposed roof flashing was found to the front corner over the left garage at the time of inspection. (See photos) This may have been caused by squirrels or other rodents and may be causing moisture intrusion to occur. Further evaluation and repair is recommended.

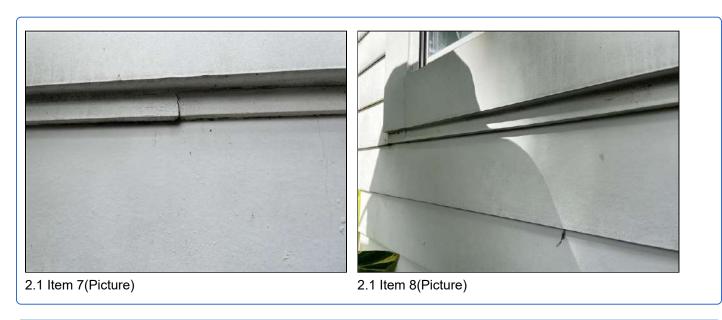
2.1 (2)

• **(Observation):** Seal any holes from the exterior to prevent issues with moisture or pests.

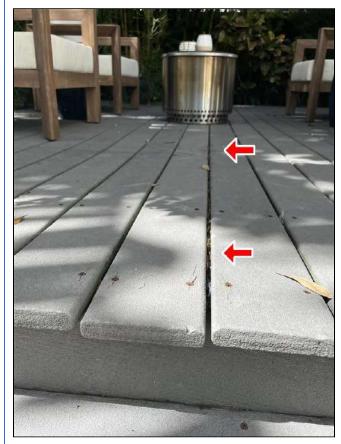
2.4 Item 6(Picture)

- **2.4** (2)
 - (Observation): The rear deck was found to have an uneven plane, which may indicate lifting by tree roots. The deck has wood rot or damage to some areas. Corrosion was found to some screws. Repair this item.

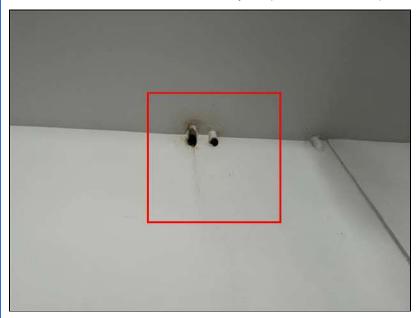
3.1 Item 4(Picture)

• (Observation): Moisture stains or staining of some sort were found to fixtures at the top of the garage wall over the water heater at the time of inspection. No active moisture appeared to be present. Have a qualified contractor evaluate and identify if repair is needed. Repair as needed.

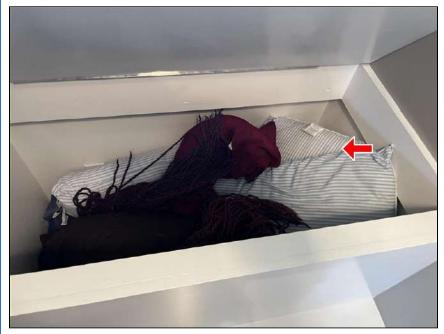
4.2 Item 1(Picture)

• **(Observation):** Some areas of the home were blocked by home owners belongings. Access to some of these areas limited our ability to visibly inspect areas.

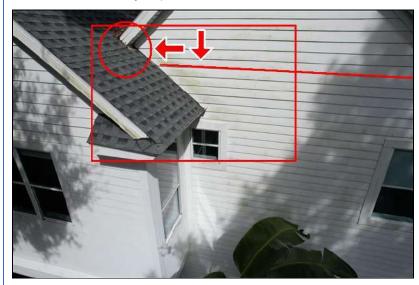
5.5 Item 18(Picture)

• **(Observation):** Wood rot, moisture stains, possible microbial growth, heavy musky odor were all noticed over the master bedroom at the time of inspection. Consult seller as to the cause of this issue. Further evaluation by a qualified contractor is recommended.

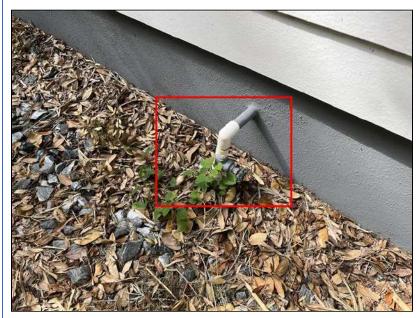
6.3 Item 1(Picture)

• (Observation): The water main shut off valve is located on the left exterior wall of the home. The main shut off at the meter, and the meter itself were not located. These were found for your neighbors homes, but the meter box for this home may be covered by grass or vegetation. Have this meter box found and exposed as well as evaluated.

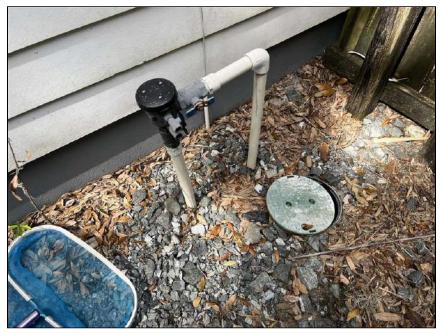
6.3 Item 4(Picture)

6.3 (2)
 (Observation): The shut off valves for the back flow were corroded at the time of inspection. Repair this

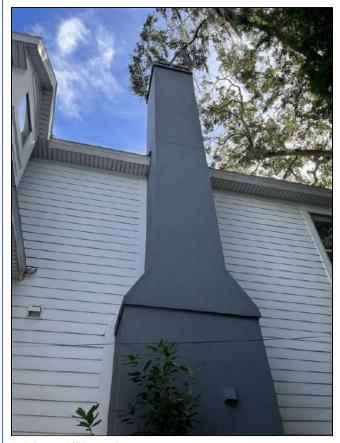
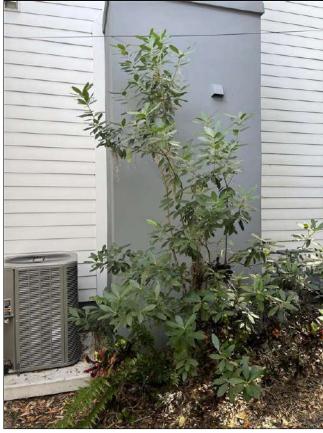
• (Observation): The chimney and fireplace were found in satisfactory condition at the time of inspection.
