WDO REPORT

Property Address:
99 Sample St, Somewhere FL, 12345

WOOD-DESTROYING ORGANISMS INSPECTION REPORT

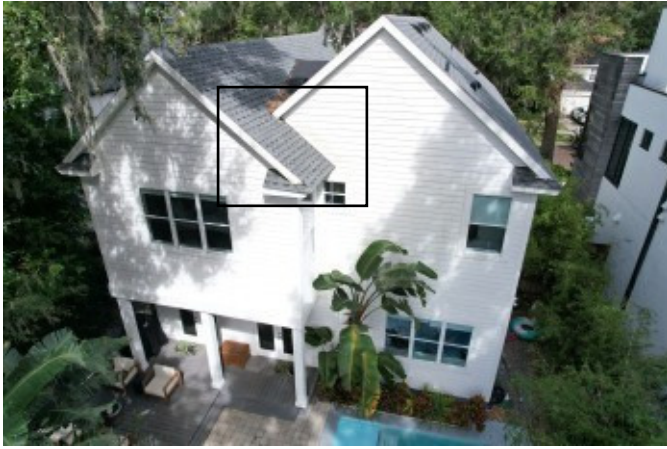
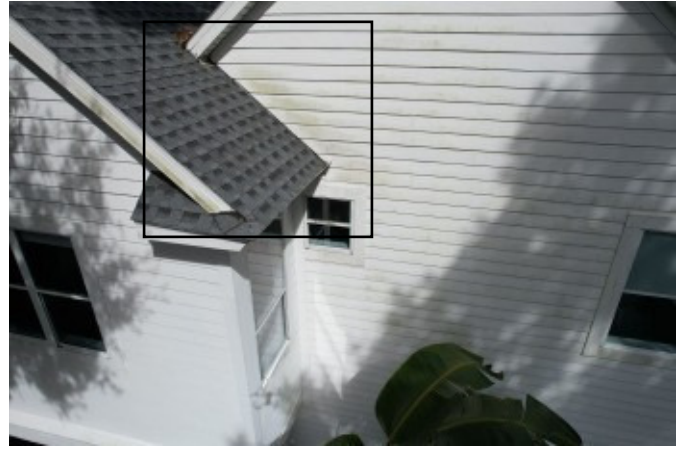
Wood rot was found to the roof decking over a section of the master bedroom roof at the rear of the home. Evidence of past moisture intrusion was visible. A strong musky odor was noticed in this area of the attic. Further evaluation by a qualified contractor is recommended.

Rear exterior location where wood rot and moisture stains and wood rot were found.

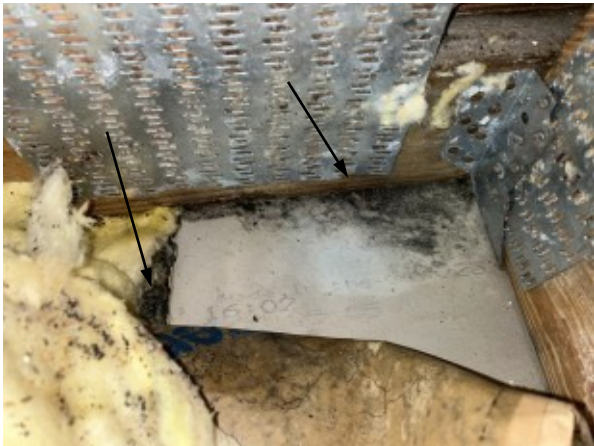
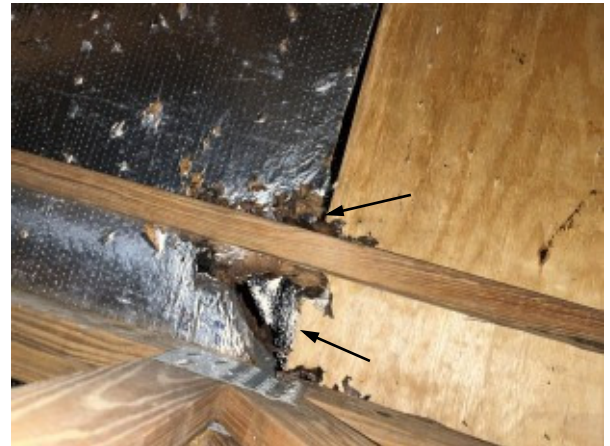
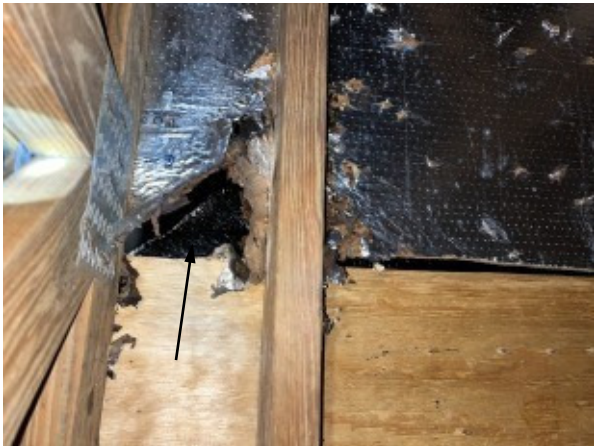
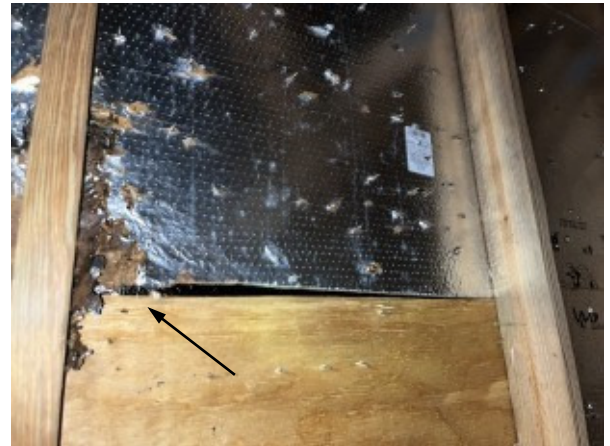
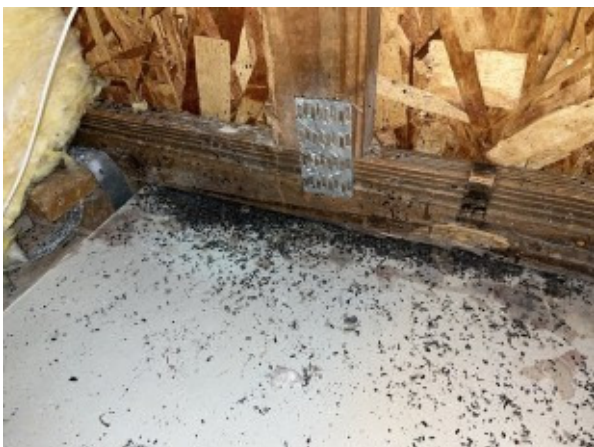
Moisture stains were found over the master bedroom to trusses and ceilings. The source of the moisture stains appears to have been a leak at the rear master bedroom wall and ceiling where wood rot was found.

Further evaluation and repair is recommended by a qualified contractor.
