Four Point Report

99 Sample St, Somewhere FL, 12345

4-Point Inspection Form

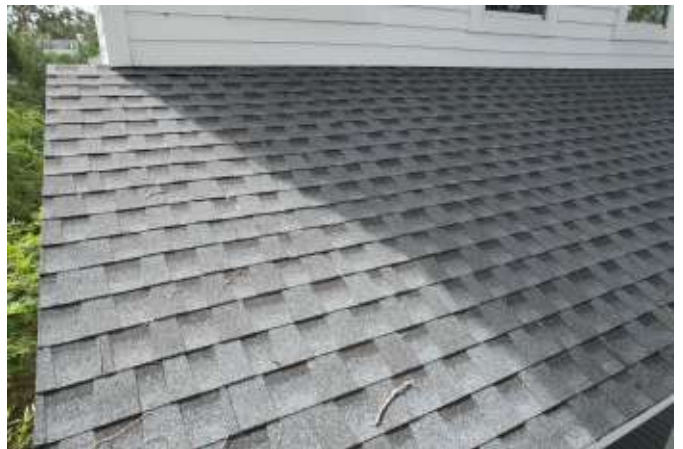
Roof:

Additional Comments/Observations (use additional pages if needed): **Wood rot and evidence of moisture intrusion in the attic indicate a potential leak.**

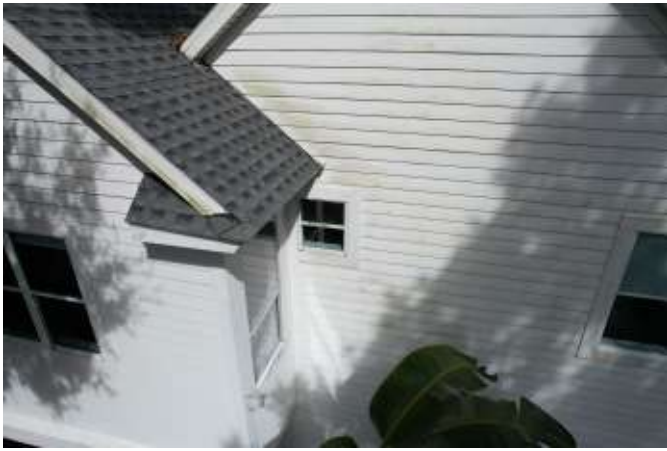
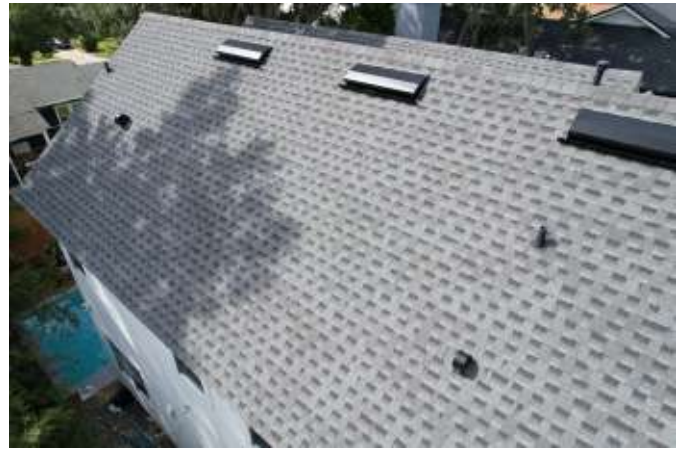
Evidence of moisture intrusion.
