Inspection Report

99 Sample St. Somewhere FL 12345

Date: 3/23/2023	Time: 11:30 AM	Report ID: 5555555
Property:	Customer:	Real Estate Professional:
99 Sample St.	Mr. John Doe	Jane Someone
Somewhere FL 12345		Top Selling Realty

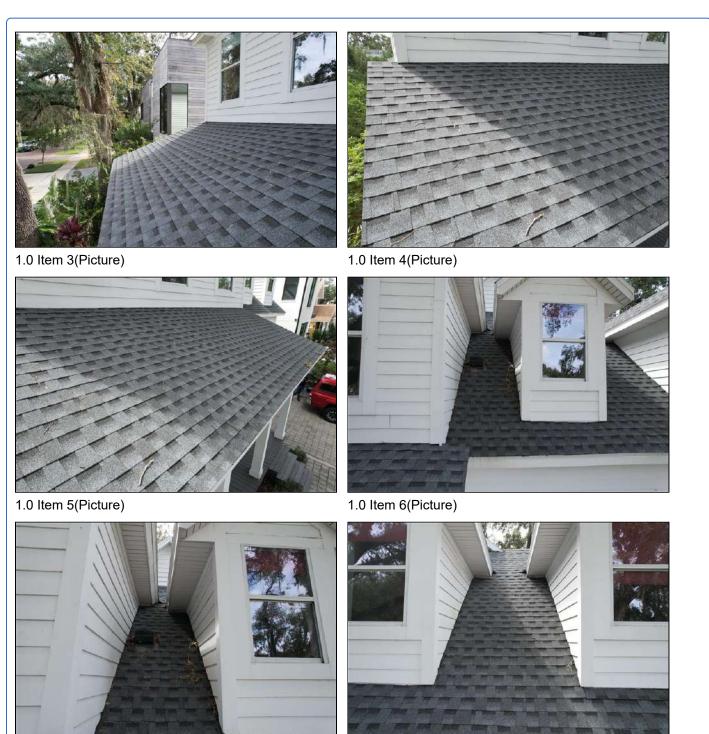
1.0 Item 7(Picture)

• (Observation): The following photos present a view of the building's roof coverings at the time of inspection. The roof covering materials are made up of architectural shingle as well as modified bitumen in lower pitch areas. These were found in overall satisfactory condition. A defect was found of an improper repair found in the attic over the master bedroom by the rear gable. See next box.

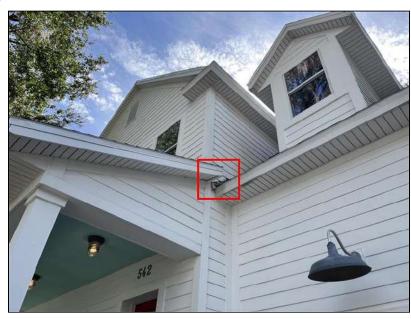
1.2 Item 1(Picture)

- **1**.2
 - (Observation): Damaged siding and exposed roof flashing was found to the front corner over the left garage at the time of inspection. (See photos) This may have been caused by squirrels or other rodents and may be causing moisture intrusion to occur. Further evaluation and repair is recommended.

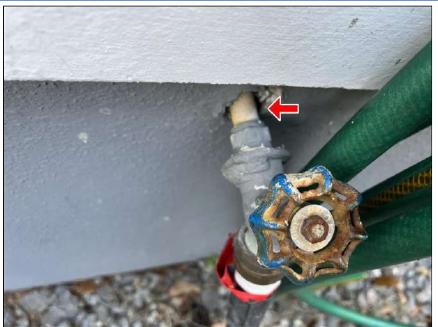
2.1 Item 9(Picture)

• **(Observation):** Seal any holes from the exterior to prevent issues with moisture or pests.

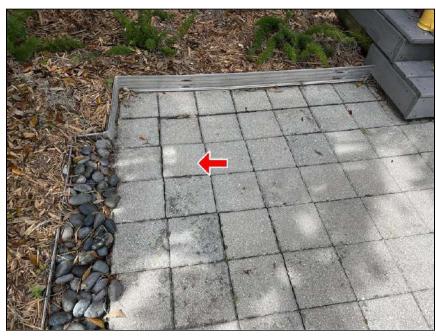
2.4 Item 4(Picture)

• (Observation): The front driveway pavers appear to have begun to buckle. This was noticed at the time of inspection. Further evaluation and repair is recommended. The back patio has a small paver area that is also showing signs of lifting. Repair this item.

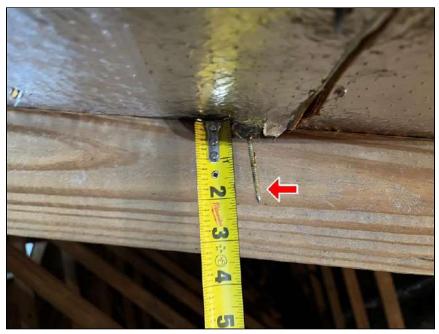
5.5 Item 3(Picture)

(Observation): Evidence of wood rot, previous water intrusion and an improper repair were found over the master bedroom attic at the time of inspection. Further evaluation by a licensed contractor is recommended. See section 5.5.

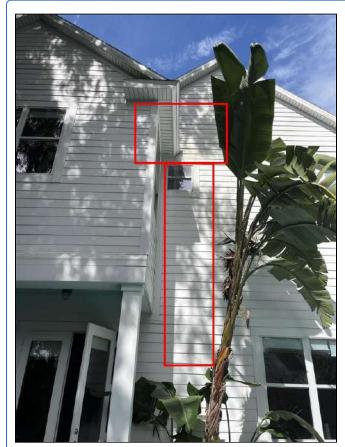
5.5 Item 19(Picture)

• **(Observation):** Wood rot, moisture stains, possible microbial growth, heavy musky odor were all noticed over the master bedroom at the time of inspection. Consult seller as to the cause of this issue. Further evaluation by a qualified contractor is recommended.

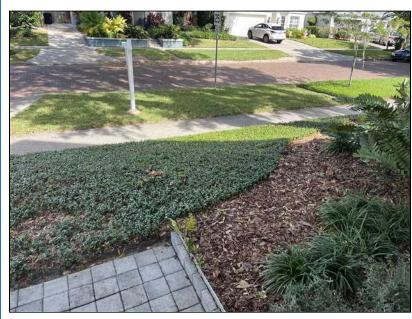
6.3 Item 2(Picture)

• (Observation): The water main shut off valve is located on the left exterior wall of the home. The main shut off at the meter, and the meter itself were not located. These were found for your neighbors homes, but the meter box for this home may be covered by grass or vegetation. Have this meter box found and exposed as well as evaluated.

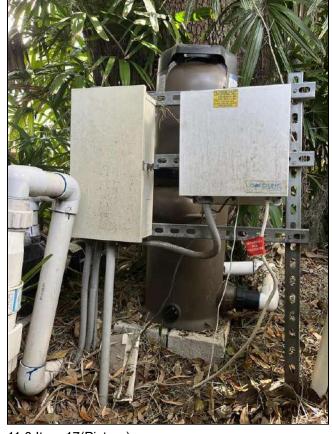
11.0 Item 17(Picture)

- The filter is placed on pavers which appear to have settled putting strain on one of the pipes. Item 14(Picture)
- The GFCI in the panel was not functioning. This may be the GFCI for the pool light. The pool light was not functioning. This may at times be caused by a leak at the panel or at the pool light. Item 16(Picture)

Further evaluation is recommended. Repair these items.
